RELIABLE HOME INSPECTIONS, LLC

HOME INSPECTION REPORT

DATE - 11-4-2016

The home that I inspected has 3 bedrooms, 2 bathrooms, a great room, living room, dining room, kitchen and a 2 vehicle carport.. It has approximately 1700 square feet and was constructed in the 1960's .The foundation is concrete block columns/piers with wood beam and joist understructure. It is wood frame with brick veneer siding. The roof structure is rafter and joist with a fiber glass composite shingle roof covering. The home has gas hot water and city water and sewer service. The home was vacant for the inspection.

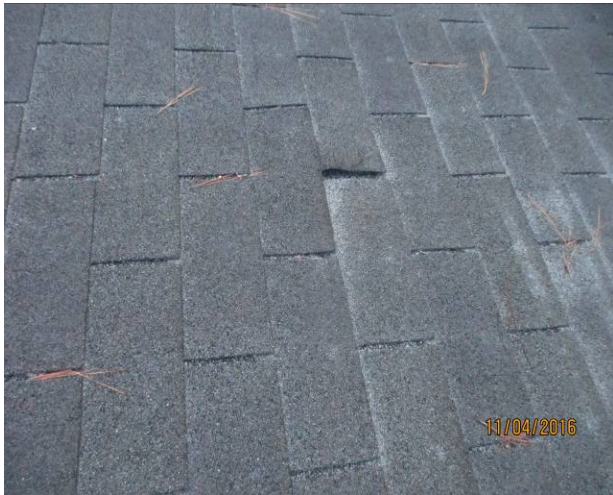
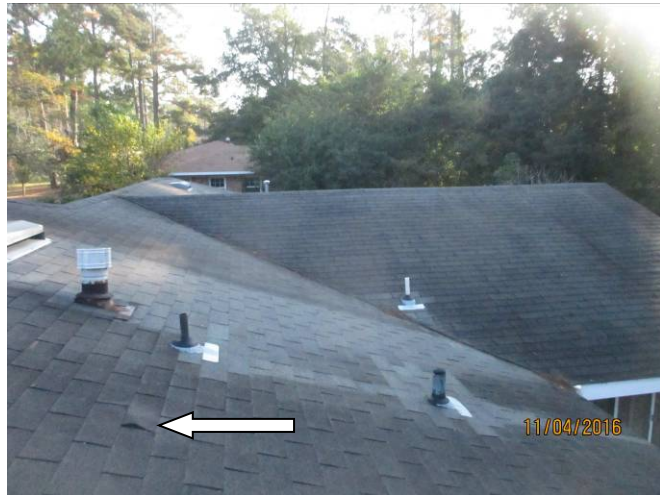
1. The roof cover is approximately 20 years old in my estimation and near the end of its anticipated service life. It has two areas where the nails have pushed the shingles up that needs to be repaired. The roof penetration boots have been replaced and there have been numerous areas of repair. The cover is old and there are a number of ceiling stains but the needed areas of maintenance have been addressed so it should last a few more years in my opinion. There is soft decking about 3 square feet in size on the back over the utility room where leakage has occurred.

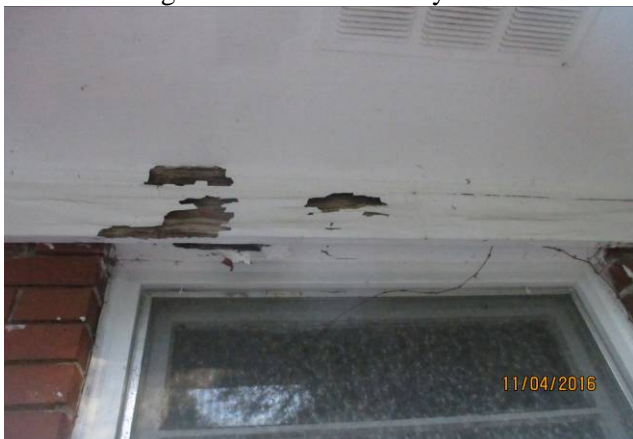
Water damage from leak over utility room

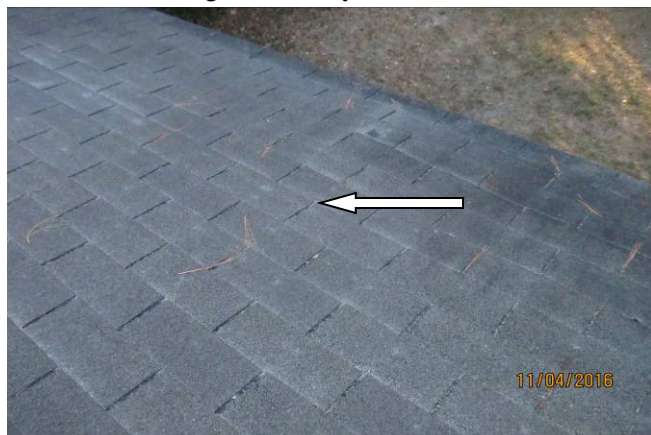
Soft decking over utility room

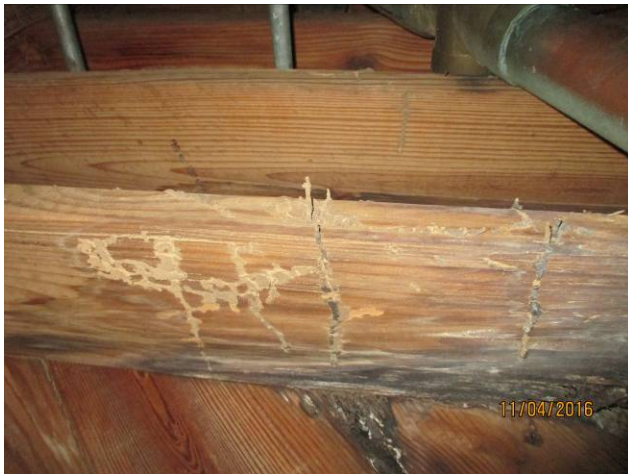
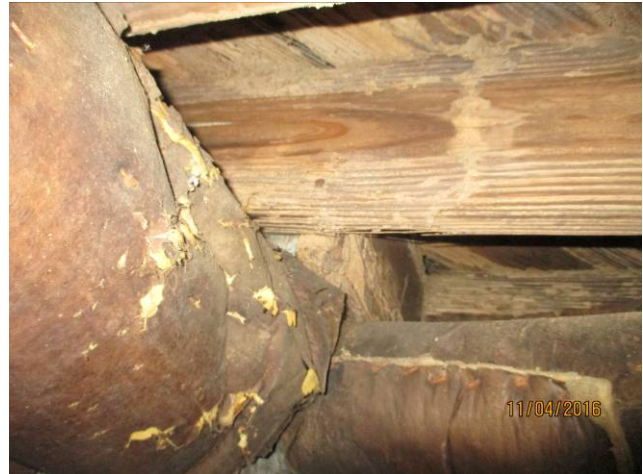
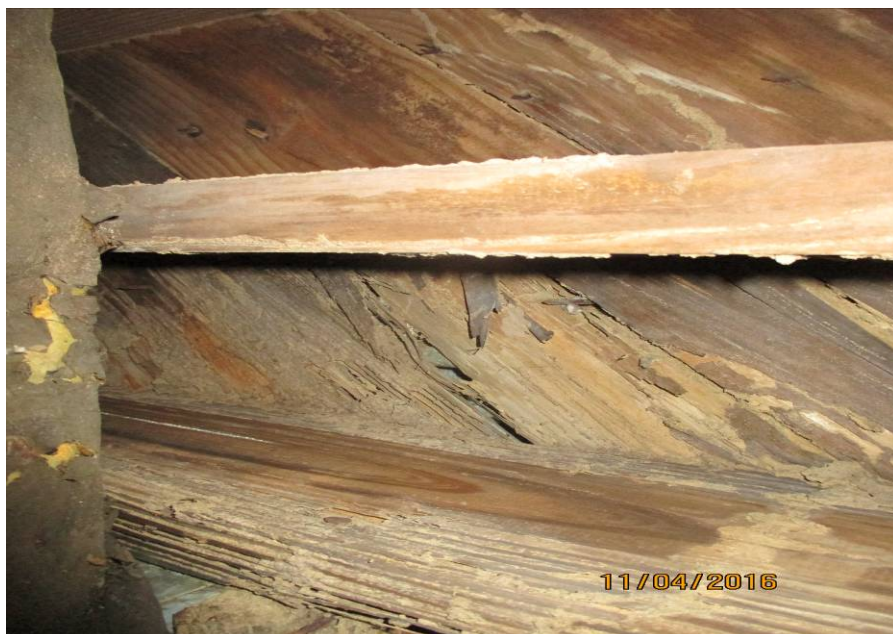
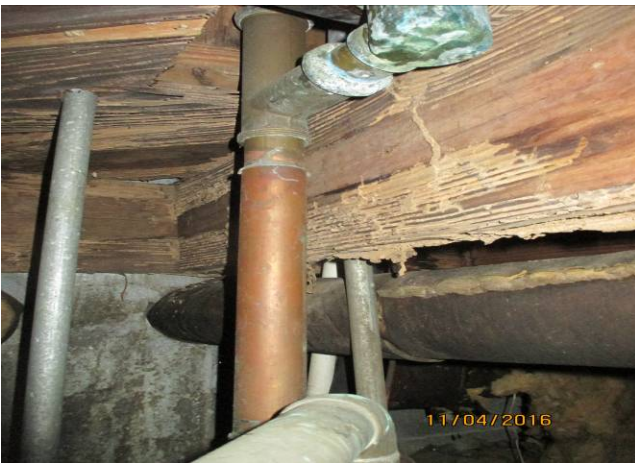
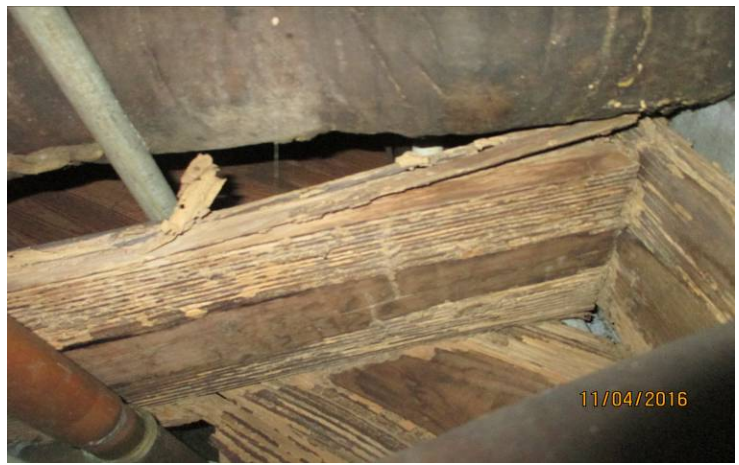
2. The floors in both bathrooms, under the air handler and part of the hall have settled approximately 2 inches in some areas. Several of the doors will not close in those areas and there are cracks radiating out from the door corners at the top as a result of the movement. The subfloor and floor joists underneath these areas have evidence of wood destroying insects that has caused structural damage and therefore contributed to the settlement. There is also some water damage under the master bathroom commode. A licensed termite inspection is recommended.

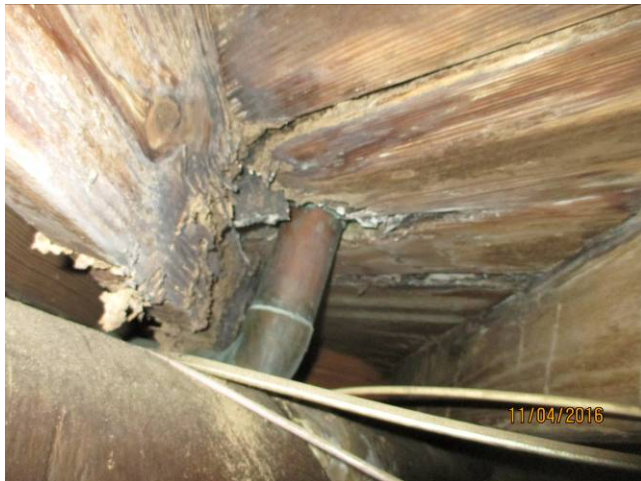
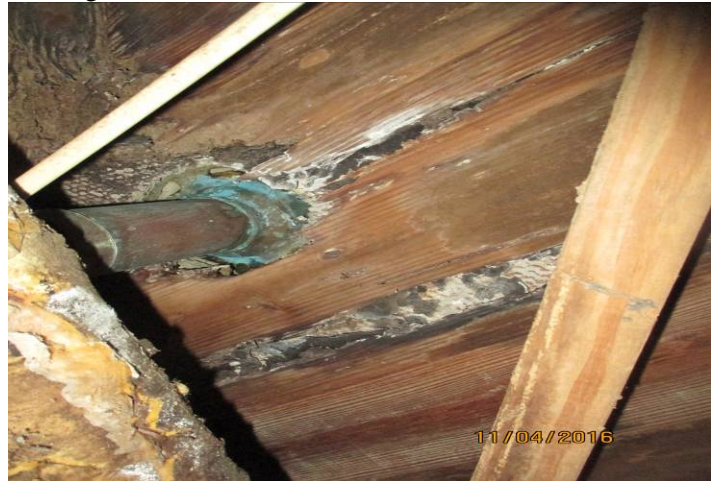
Master bath water damage

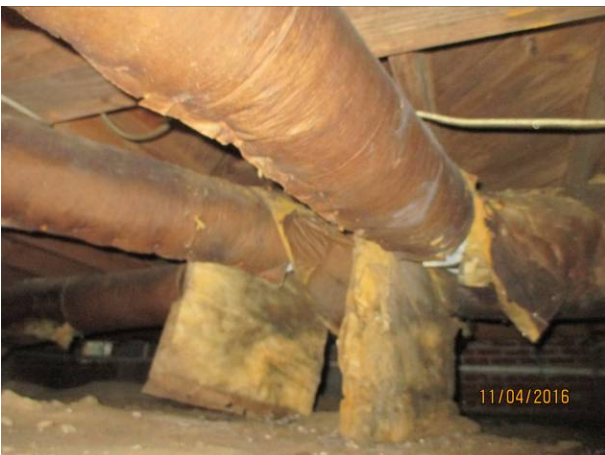
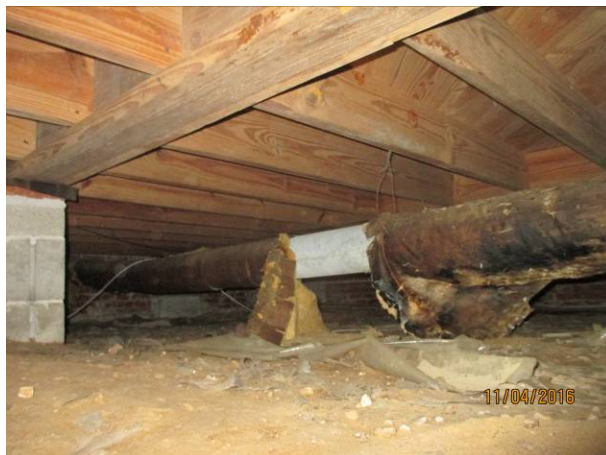
3. The west side exterior wall is missing a crawl space vent register.
4. The porch fans need replacement.
5. The disposal would not operate.
6. The wood windows are painted closed and therefore stuck.
7. There are many areas of duct insulation that has fallen off partially. Taping as necessary is recommended.

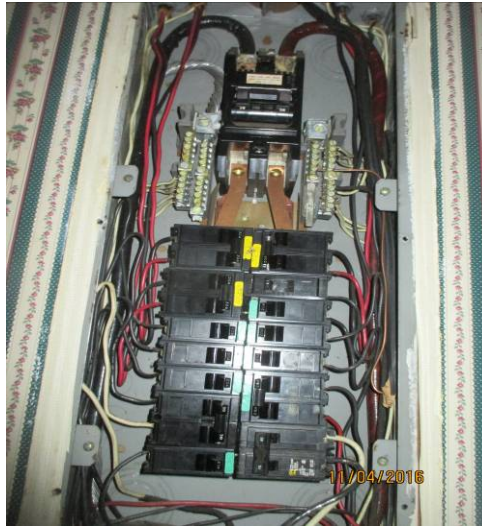
1. **ELECTRICAL-** The electrical service panel is 150 amp. The 110 volt branch conductors are copper. The branch circuits are two conductor. There is no limited ground fault protection on the homes exterior due to the date of construction however it is recommended in the high risk areas. There were an adequate number of outlets that were randomly tested and found to be in functional condition. The over head lighting and switches operated properly as well as the ceiling fans and bathroom exhaust fans where applicable.

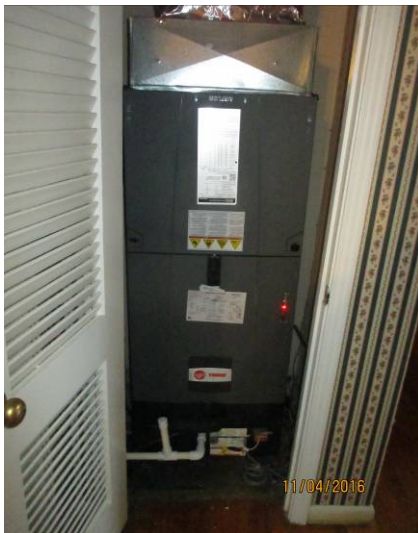
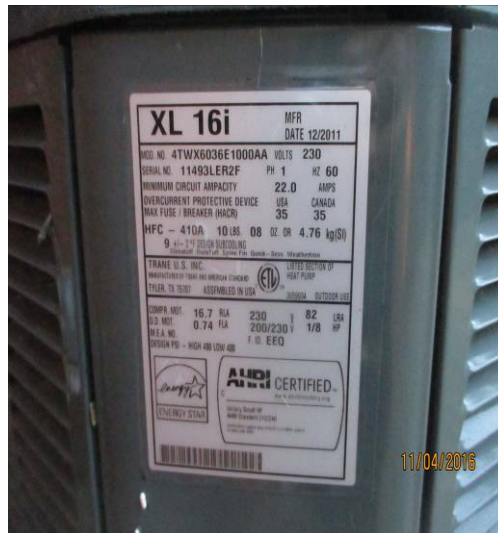
3. **HVAC-** The heating and cooling of the home is accomplished by a 3 ton Trane split system heat pump built in 2011. The evaporator component is in a closet and is a 2011 model as well. I ran the system in cool mode. Its operation was within normal temperature parameters. The visible sections of ducting were adequately insulated, sealed and properly suspended. There is one PVC condensate drain pipe and a level sensor for condensate control. Cleaning and testing of the condensate drainage components are recommended both initially and annually going forward.

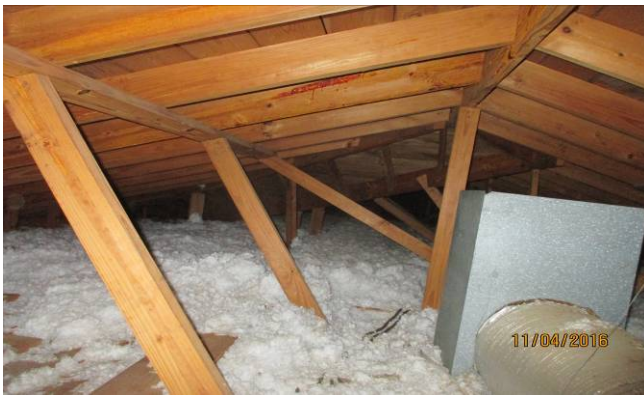
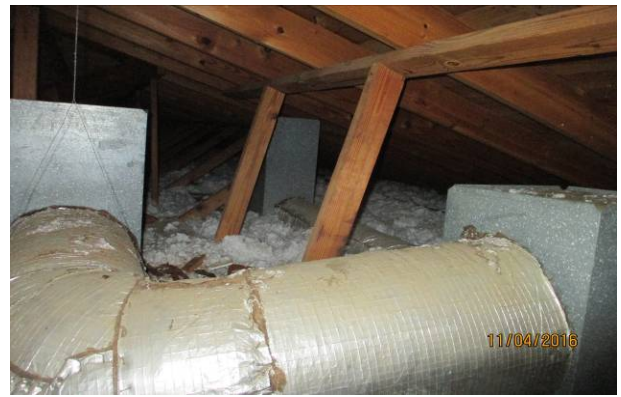
4. **INSULATION/VENTILATION-** The attic insulation is blown in fiberglass. There is approximately 10-12 inches of thickness which should provide an R-30 energy rating. The attic is vented by soffit vents, roof vents

and gable vents which should be adequate. There are areas of the attic that are not safely accessible due structural congestion and no walk ways.
